# HVM “Golden Recipe” Methodology for SiC Substrate Qualification Across Suppliers

## Part 2

SiC Substrate Defects Have Outsized Impact on Reliability & Yield

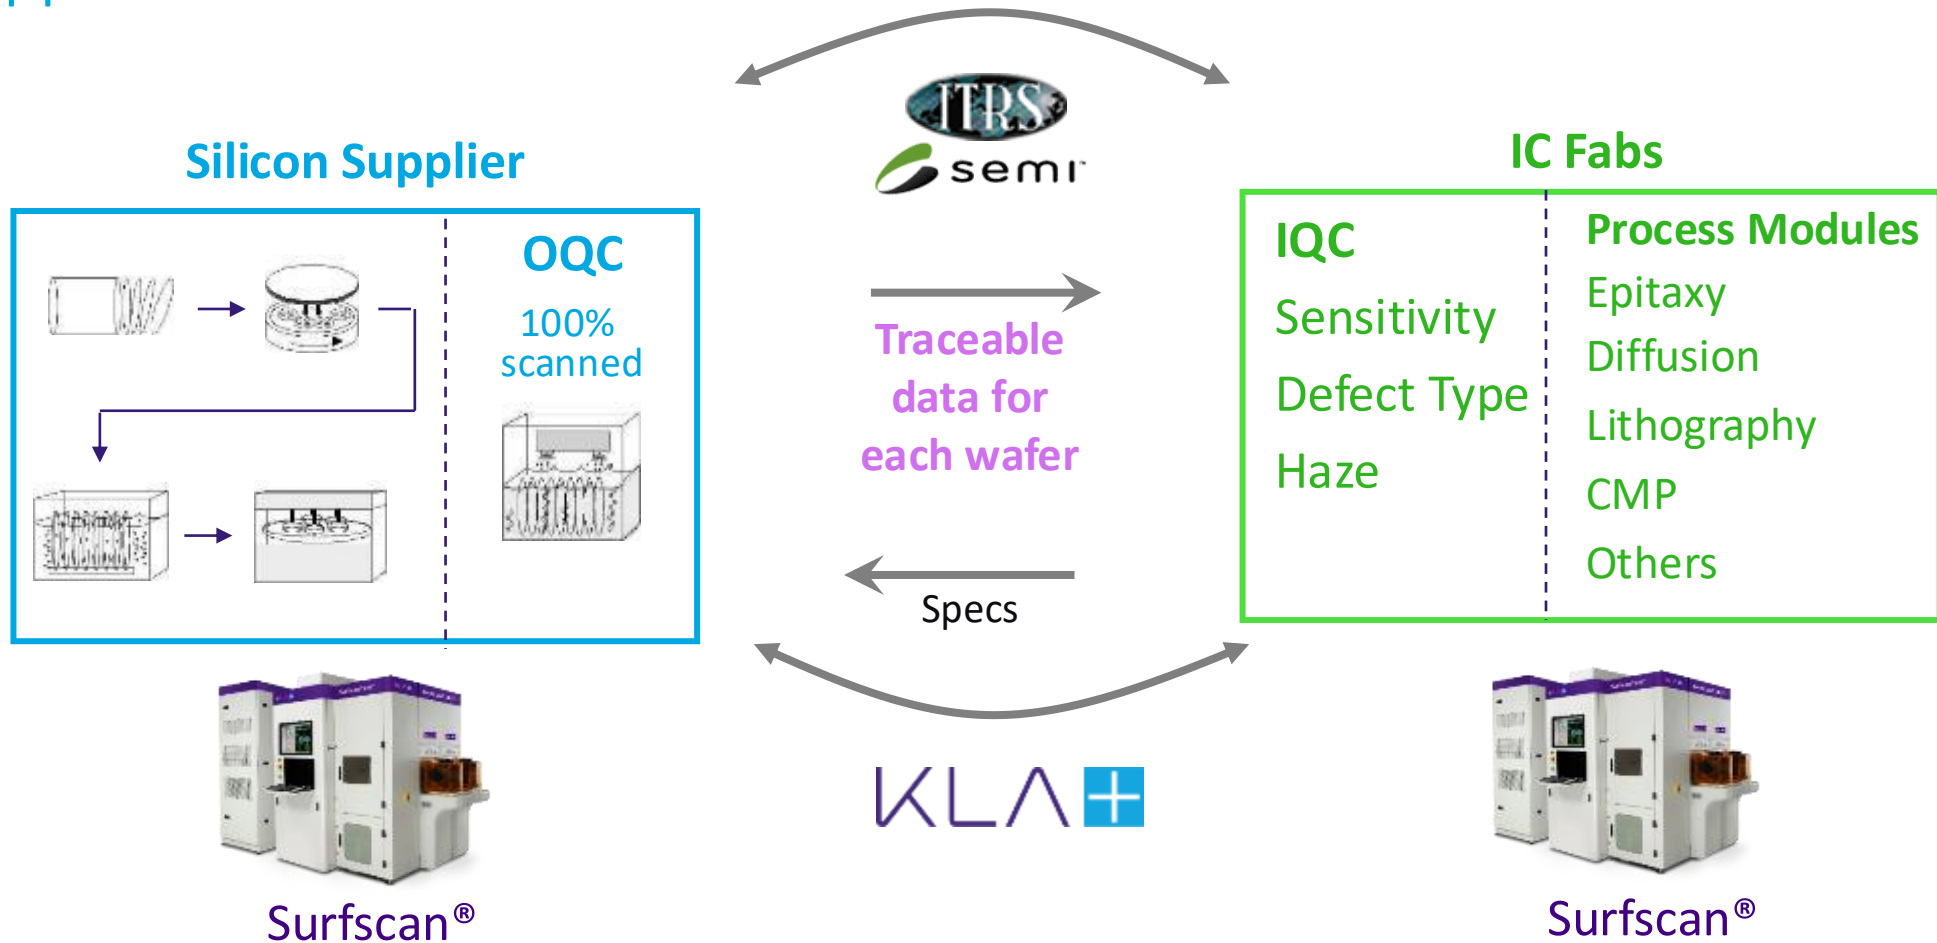
## Silicon Supplier – Fab Handoff

SEMI (industry) standard M59 mandates monitoring of killer defect types in Silicon. M81 controls Silicon Carbide

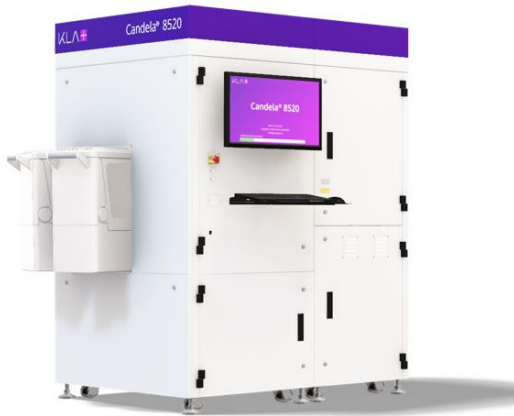
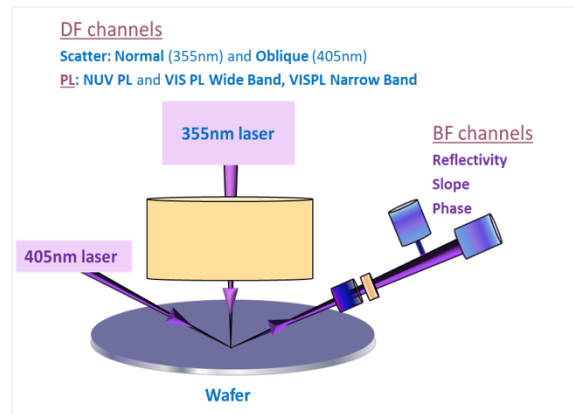
## Candela® 8520

<1µm sensitivity  
~12WPH @8"

### 405&355nm Laser

## ■ Original specialty substrate inspector

- 25-year history. 300+ Candela 8520 field units
- Engineering roots: agile/tunable multi-incidence, multi-detector, onboard analysis

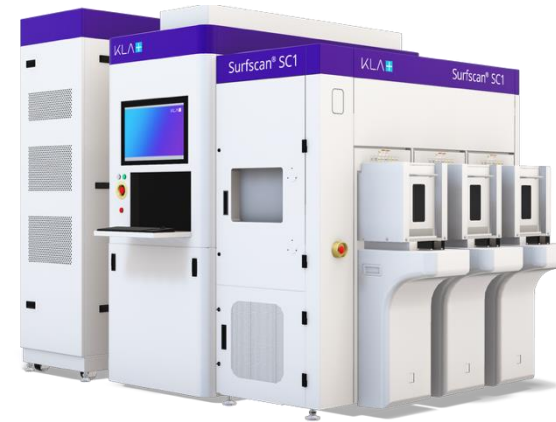
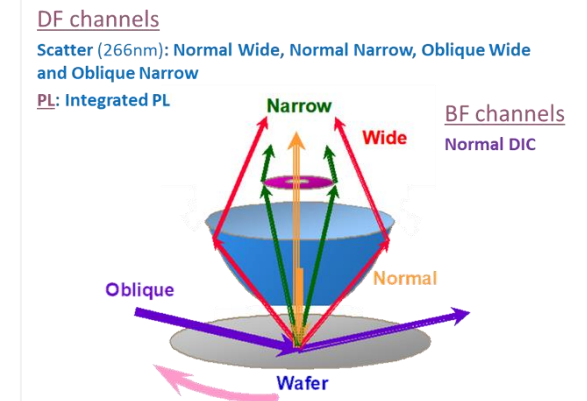
## Surfscan® SC1

<100nm sensitivity  
~32-110WPH @8"

### 266nm Laser

## ■ Extension of HVM Si industry standard

- Built on SPx platform, 1000+ production units
  - Darkfield, Haze, PL. SiC and Si
- Repeatable, matchable

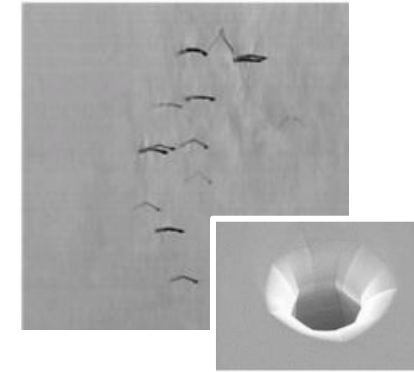
Micropipe

SEM Image

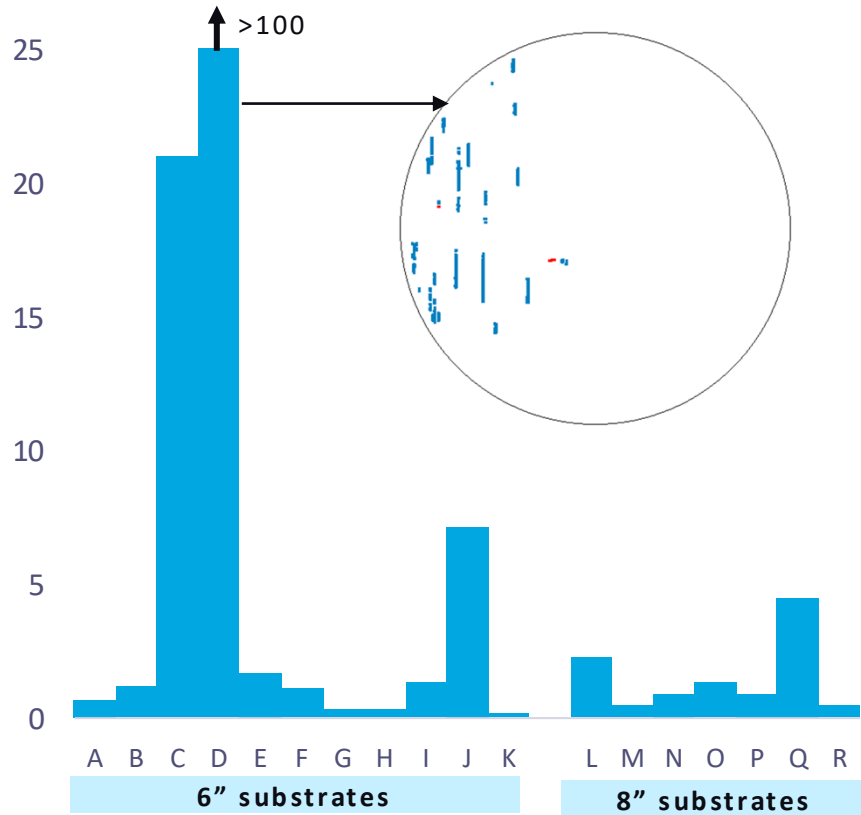
Avg. # of stacking faults per wafer

Substrate Supplier

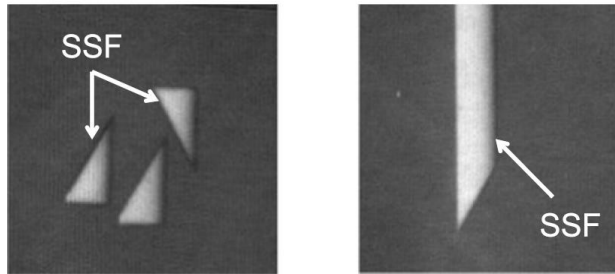
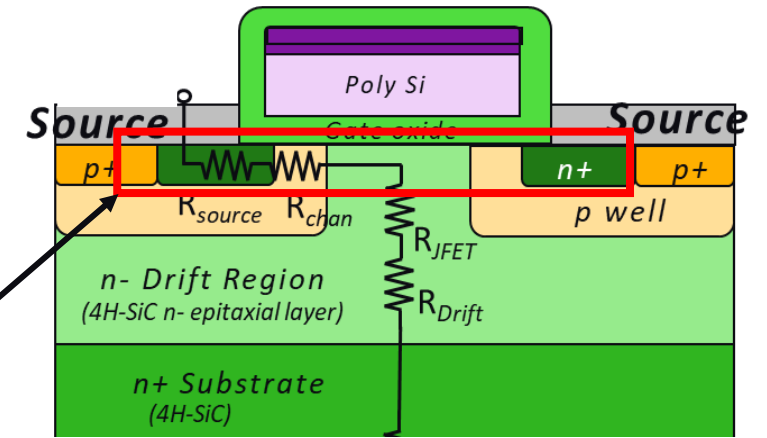
Stacking faults can lead to reliability defect (Bipolar Degradation) through increased resistance in the area covered by the grown SSF

Defect images from: Kimoto, T. "Defect engr. in SiC technology for HV power devices" (2020 Appl. Phys. Exp 13 120201)

## Mitigation:

1. Electrical verification measures
2. Defect screening- ink wafer areas with high defect density.

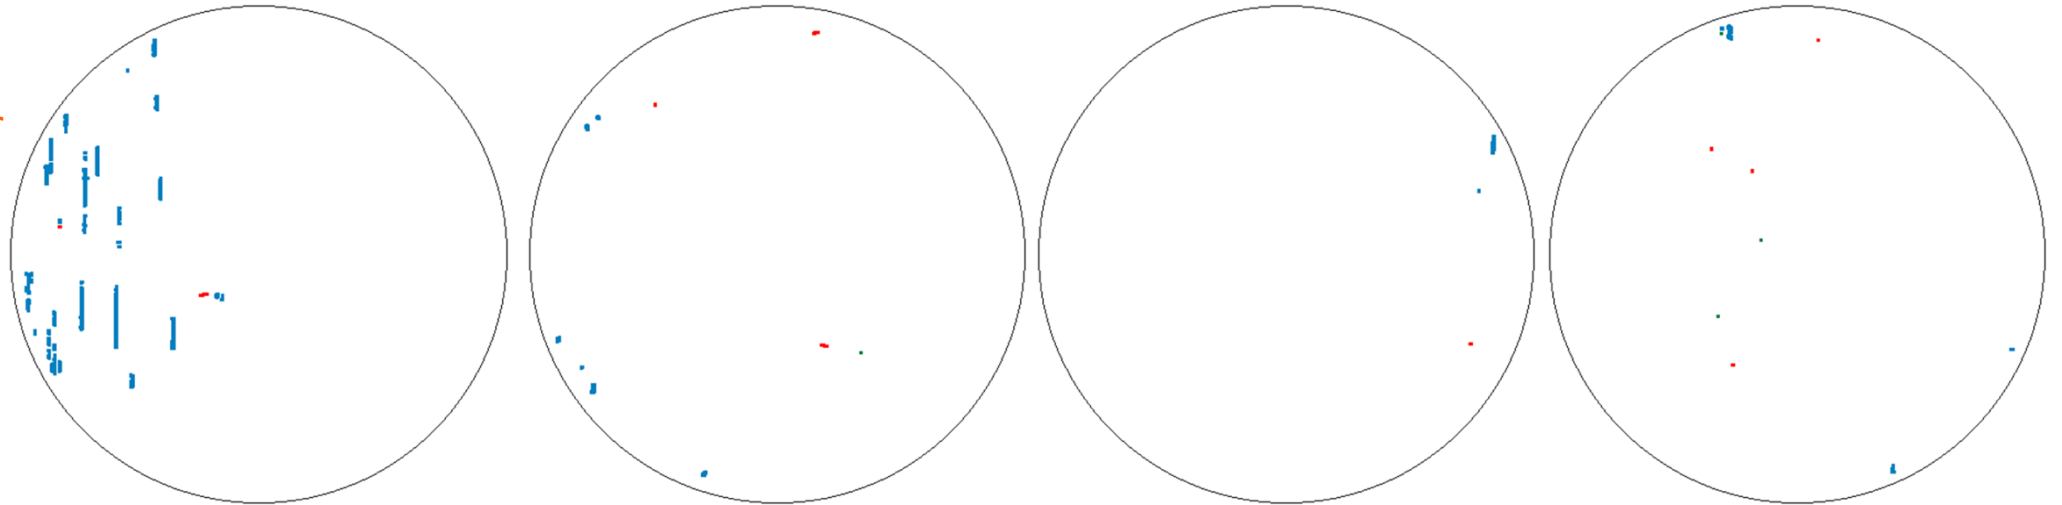
# Sample Defect Maps: Stacking Faults

Variation drives 100% sampling

Supplier C

Maverick Wafer  
(same boule)

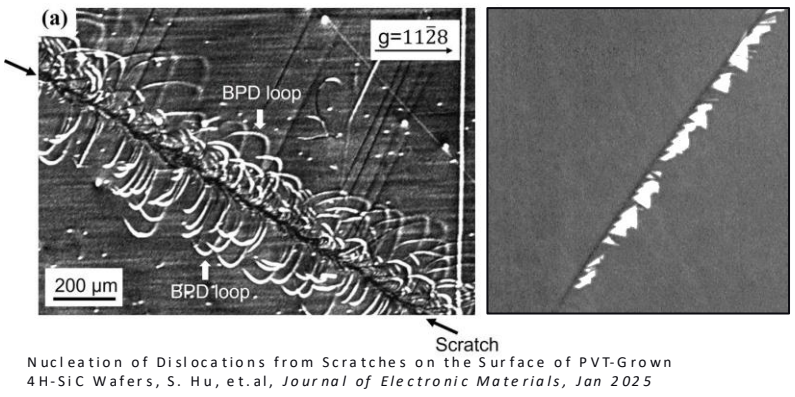
## Scratches can be a nucleation site for defect growth

Nucleation of Dislocations from Scratches on the Surface of PVT-Grown 4H-SiC Wafers, S. Hu, et.al, *Journal of Electronic Materials*, Jan 2025

- BPD Loops
- TEDs (prismatic slip)
- Partial dislocation loop expansion
- Stacking faults, step bunching at EPI

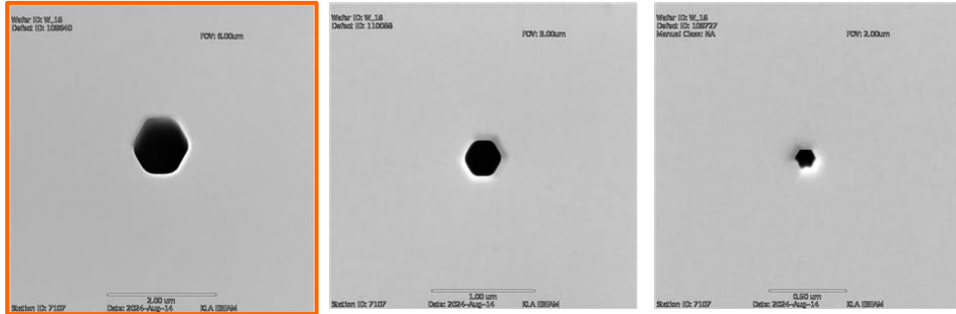
Killer defect: varied sizes

Current industry sensitivity

~800-1000nm

~300nm

~100nm

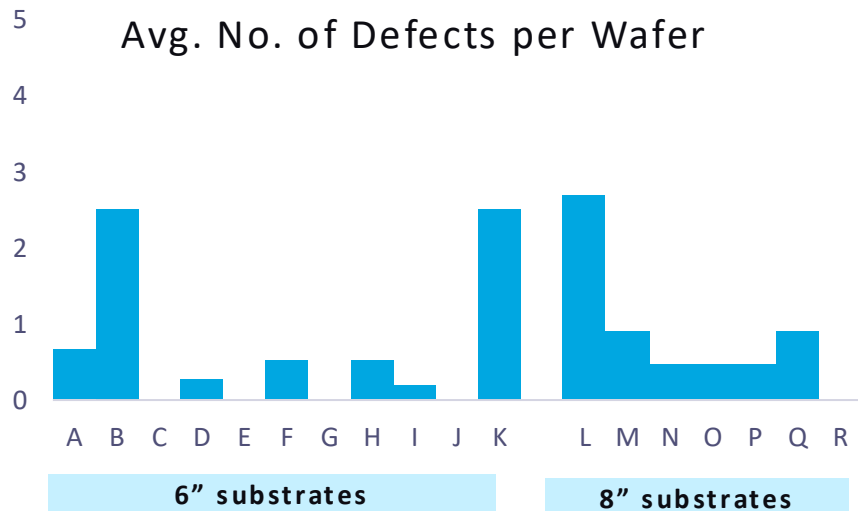
Substrate Supplier

Micropipe density decreasing:  $< .1/cm^2$

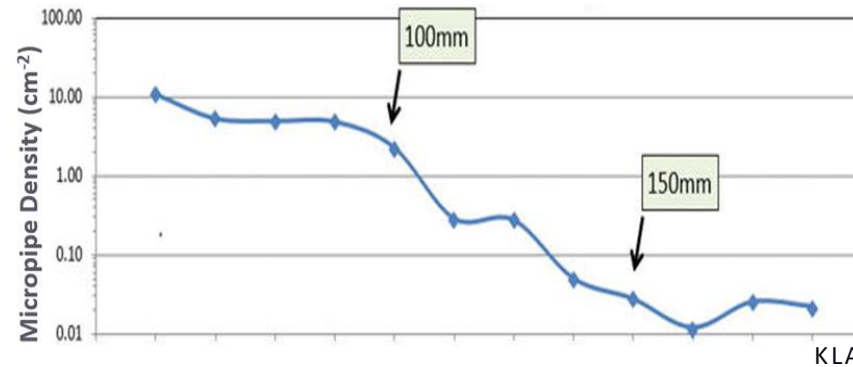
- Smaller diameter micropipes exist
- Characterizing ~100nm now on SC1
- SEM intensive

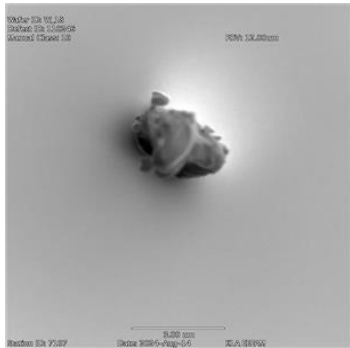
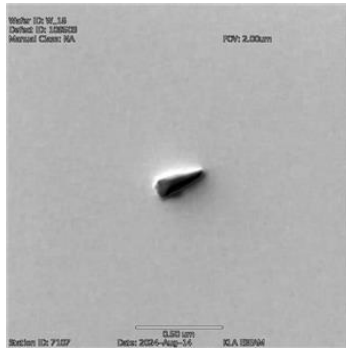
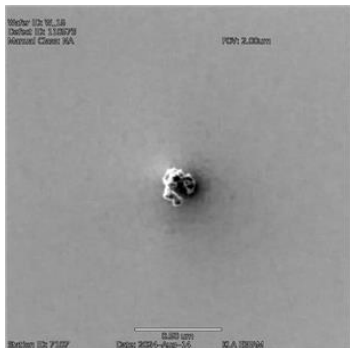
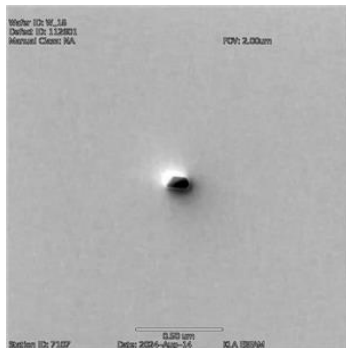
Cleanable\* and embedded

~5 um

~300nm

~150nm

<100nm

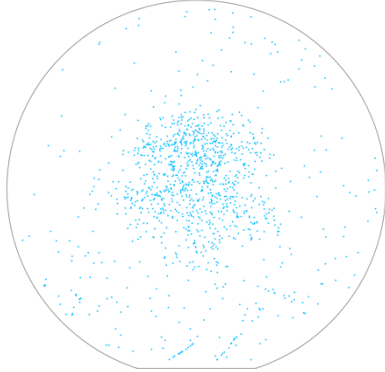
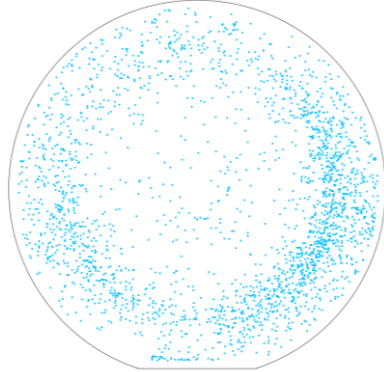
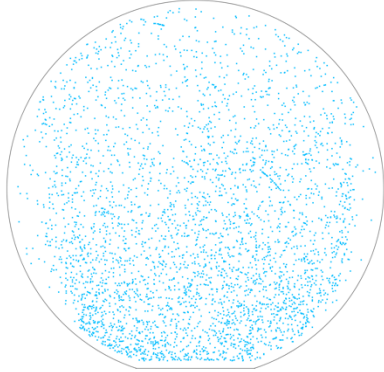
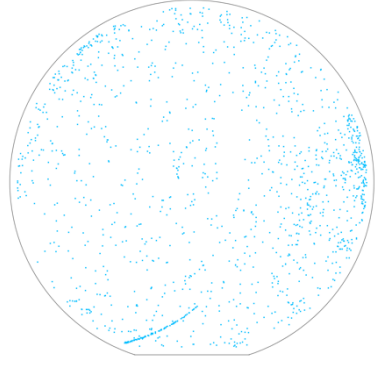
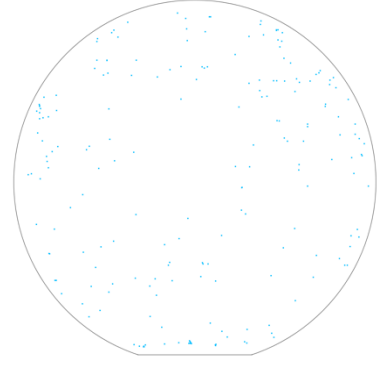
# Supplier Particle Comparisons at 125 WPH (6" wafers)

Best

1231

2504

3669

1370

204

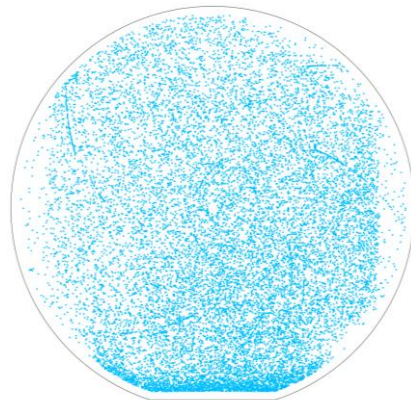
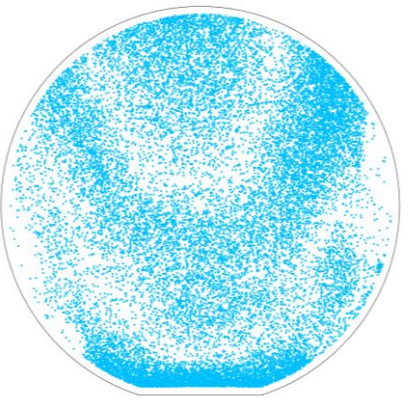
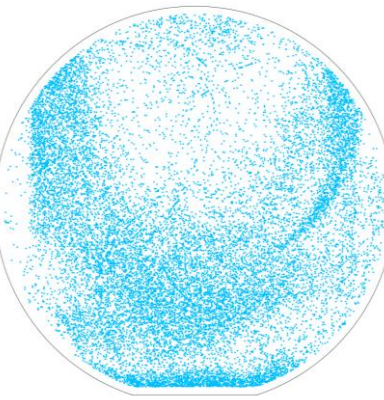
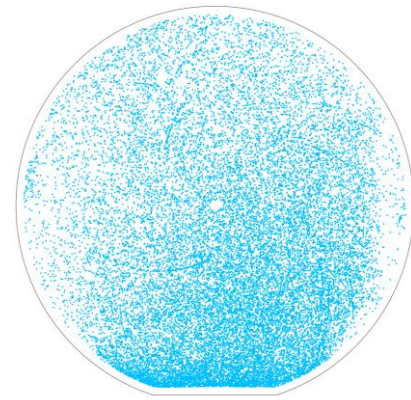
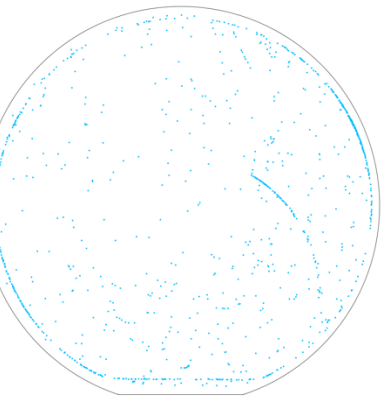
Worst

16702

20742

18171

23124

1027

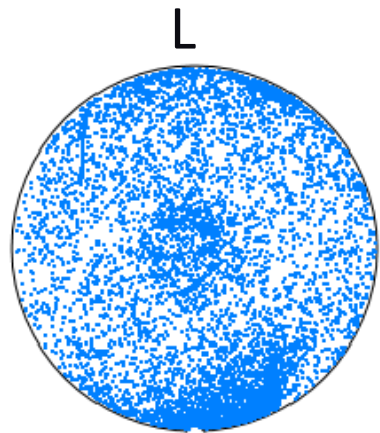
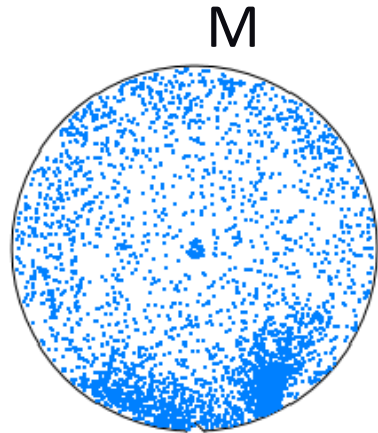
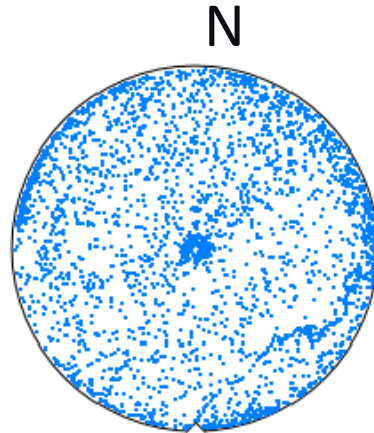
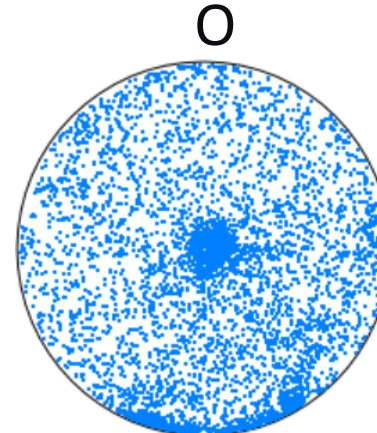
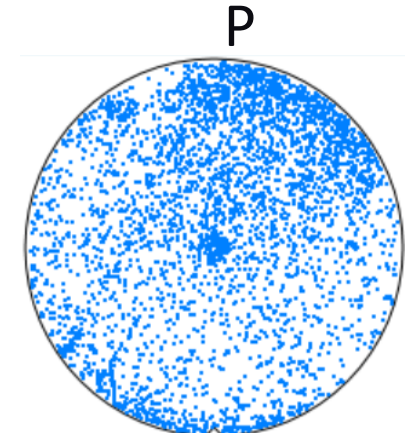
# Supplier Particle Comparisons at 110 WPH (8" wafers)

Best

7312

4015

3367

6783

4611

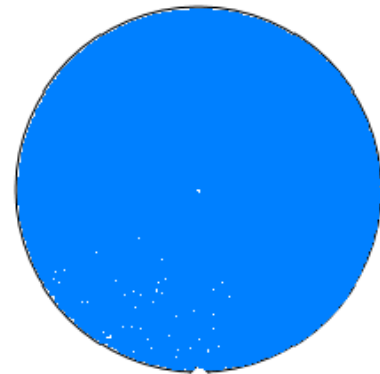
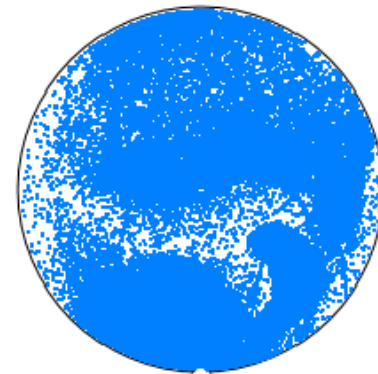
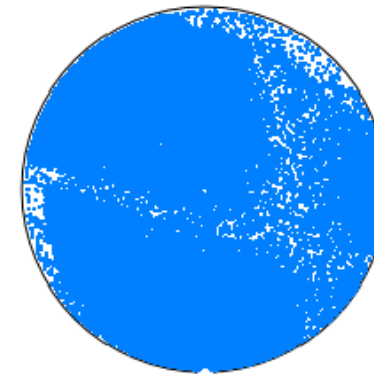
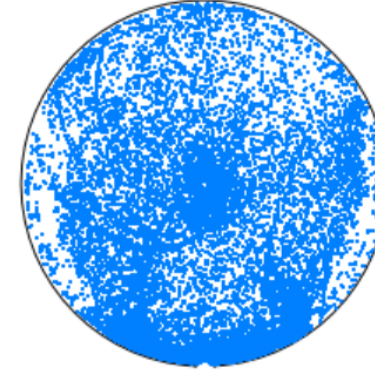
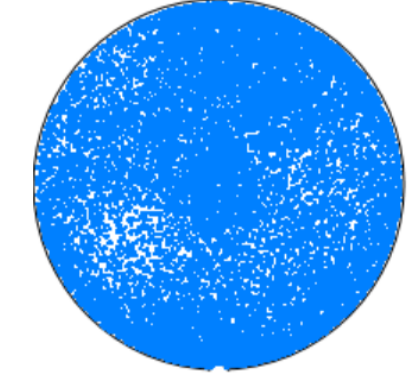
Worst

85271

52239

73304

18175

30335
